HOME REPORT

52 STEWART ROAD
FALKIRK
FK2 7AW

Energy Performance Certificate (EPC)

Single Survey

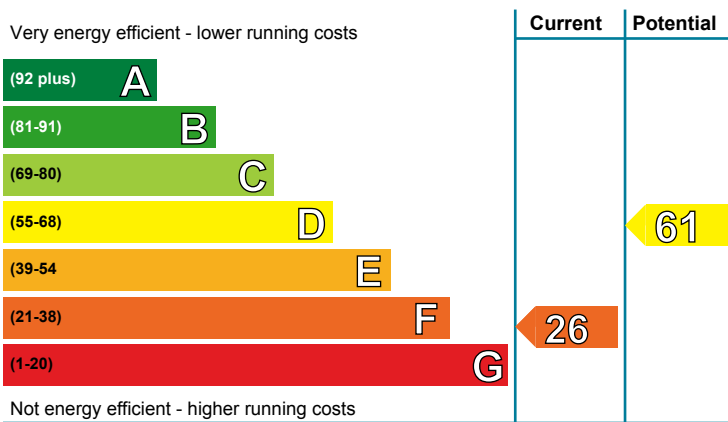
Energy Efficiency Rating

This graph shows the current efficiency of your home, taking into account both energy efficiency and fuel costs. The higher this rating, the lower your fuel bills are likely to be.

Your current rating is **band F (26)**. The average rating for EPCs in Scotland is **band D (61)**.

The potential rating shows the effect of undertaking all of the improvement measures listed within your recommendations report.

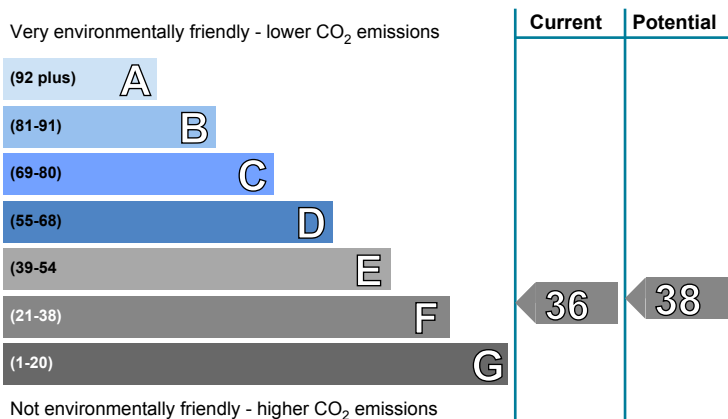
Environmental Impact (CO₂) Rating

This graph shows the effect of your home on the environment in terms of carbon dioxide (CO₂) emissions. The higher the rating, the less impact it has on the environment.

Your current rating is **band F (36)**. The average rating for EPCs in Scotland is **band D (59)**.

The potential rating shows the effect of undertaking all of the improvement measures listed within your recommendations report.
