8A High Street,
Penicuik,
EH26 8HW

Home Report

Single Survey

Property Address	8A High Street, Penicuik, EH26 8HW
Reference	1595509
Customer Name	Cara Baldwin
Date of Inspection	26th May 2026
Surveyor's name, qualifications and office	Jamie Biggar MRICS DM Hall LLP Chartered Surveyors 17 Corstorphine Road Edinburgh EH12 6DD tel: 0131 624 6600 email: edinburghresidential@dmhall.co.uk
Prepared By	DM Hall LLP

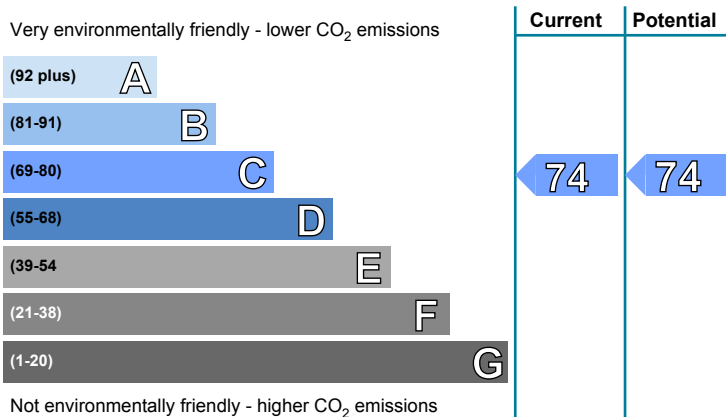
Environmental Impact (CO₂) Rating

This graph shows the effect of your home on the environment in terms of carbon dioxide (CO₂) emissions. The higher the rating, the less impact it has on the environment.
